ENGINEERING STUDY OF SELECTED LOCATIONS EXPERIENCING HIGH ACCIDENT FREQUENCY UNDER SNOWY AND ICY ROADWAY CONDITIONS

PREPARED BY
PROJECT PLANNING SECTION
PLANNING AND RESEARCH BUREAU
ENGINEERING DIVISION
MONTANA DEPT. OF HIGHWAYS

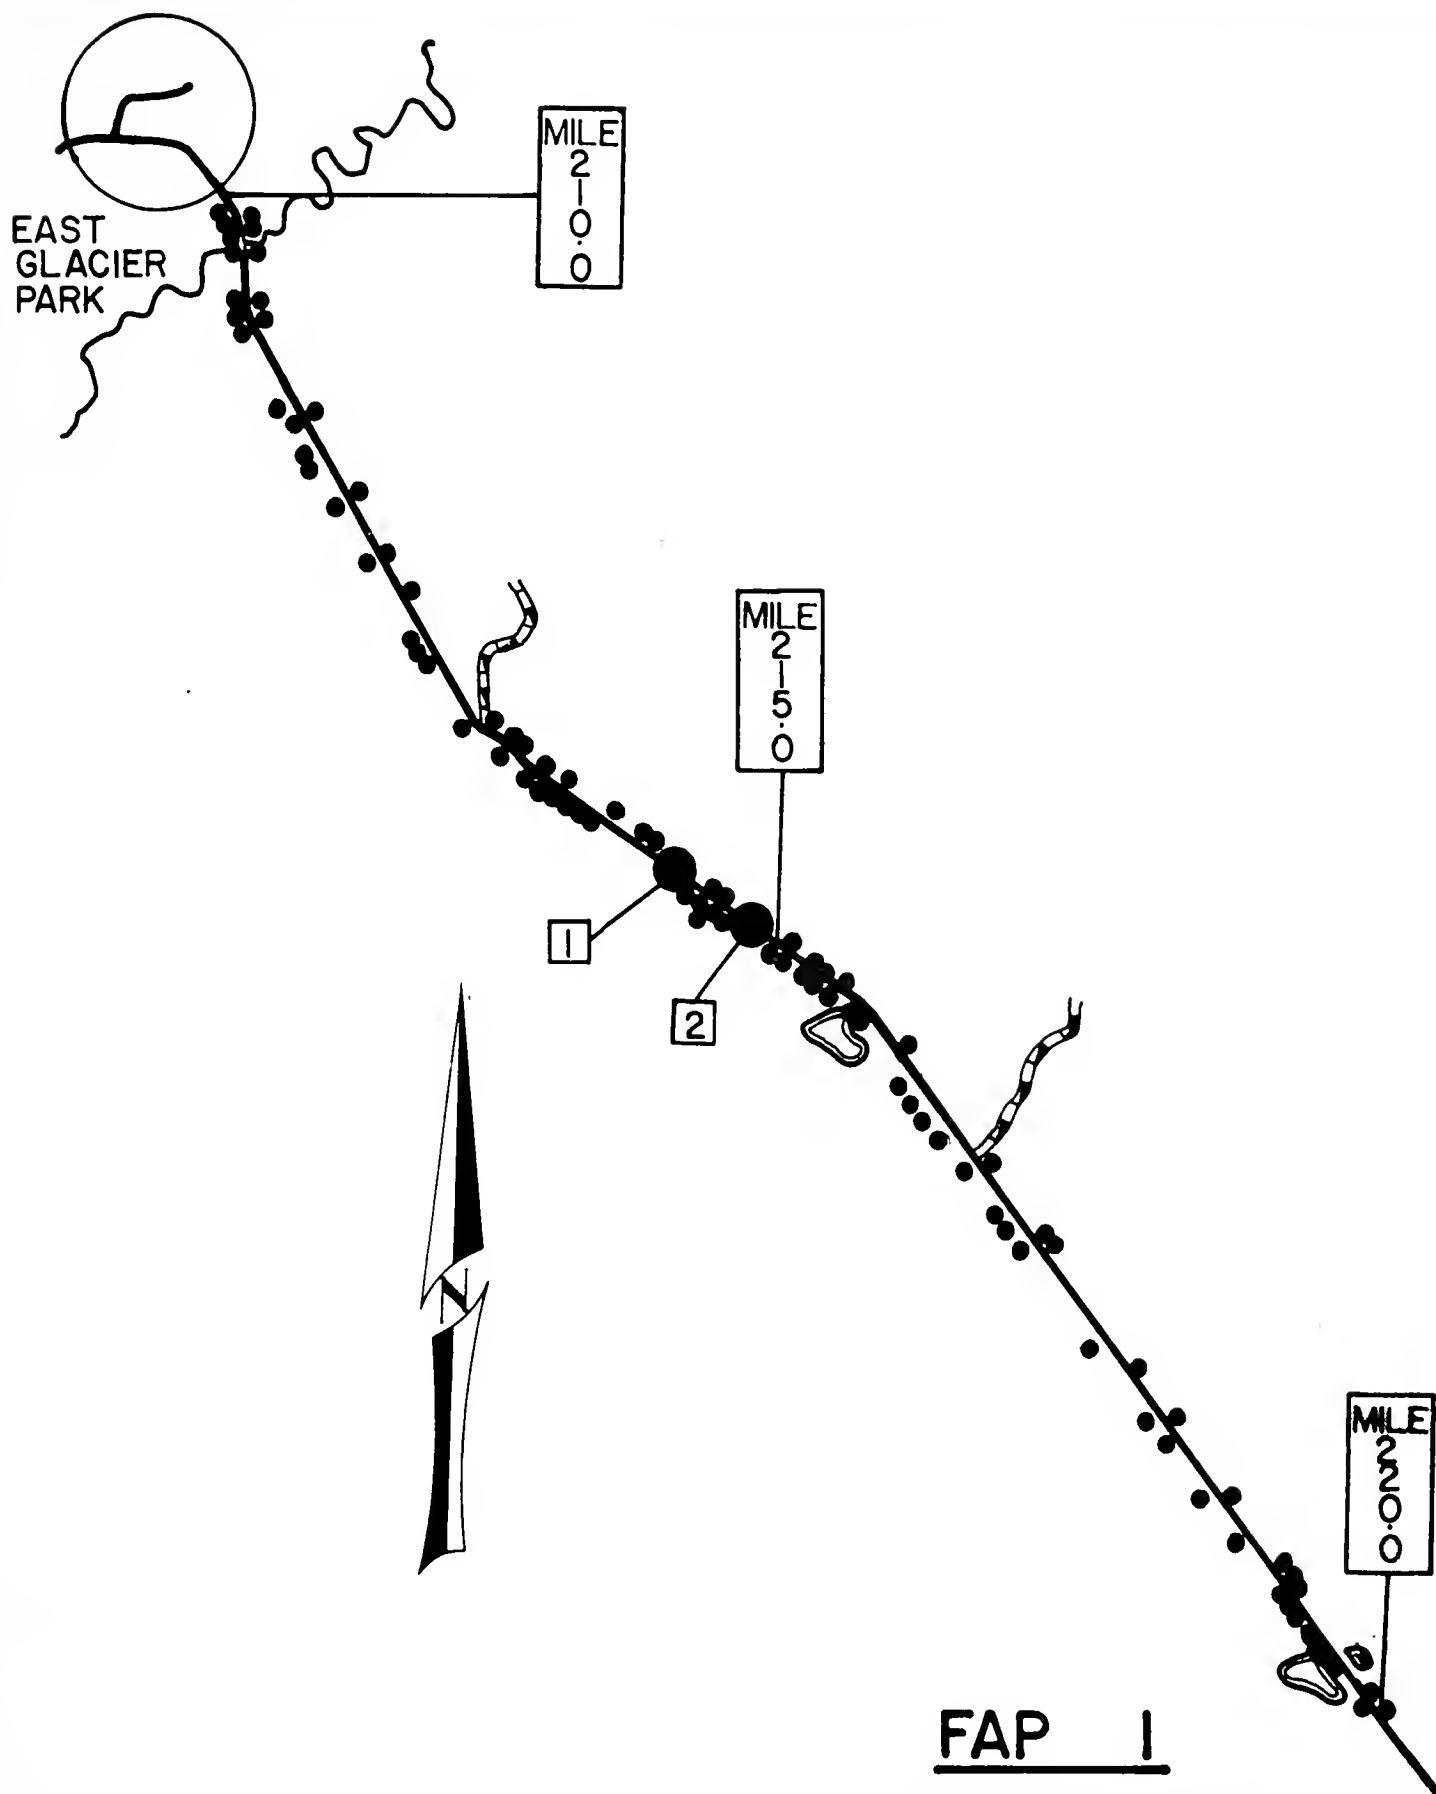
MILEPOST 210 - MILEPOST 220

Comment: Accident history is spread out through the study area. A reduction in accident occurrence is noted on the newer constructed section. A clustering of accidents has occurred on or near the Two Medicine Bridge east of East Glacier.

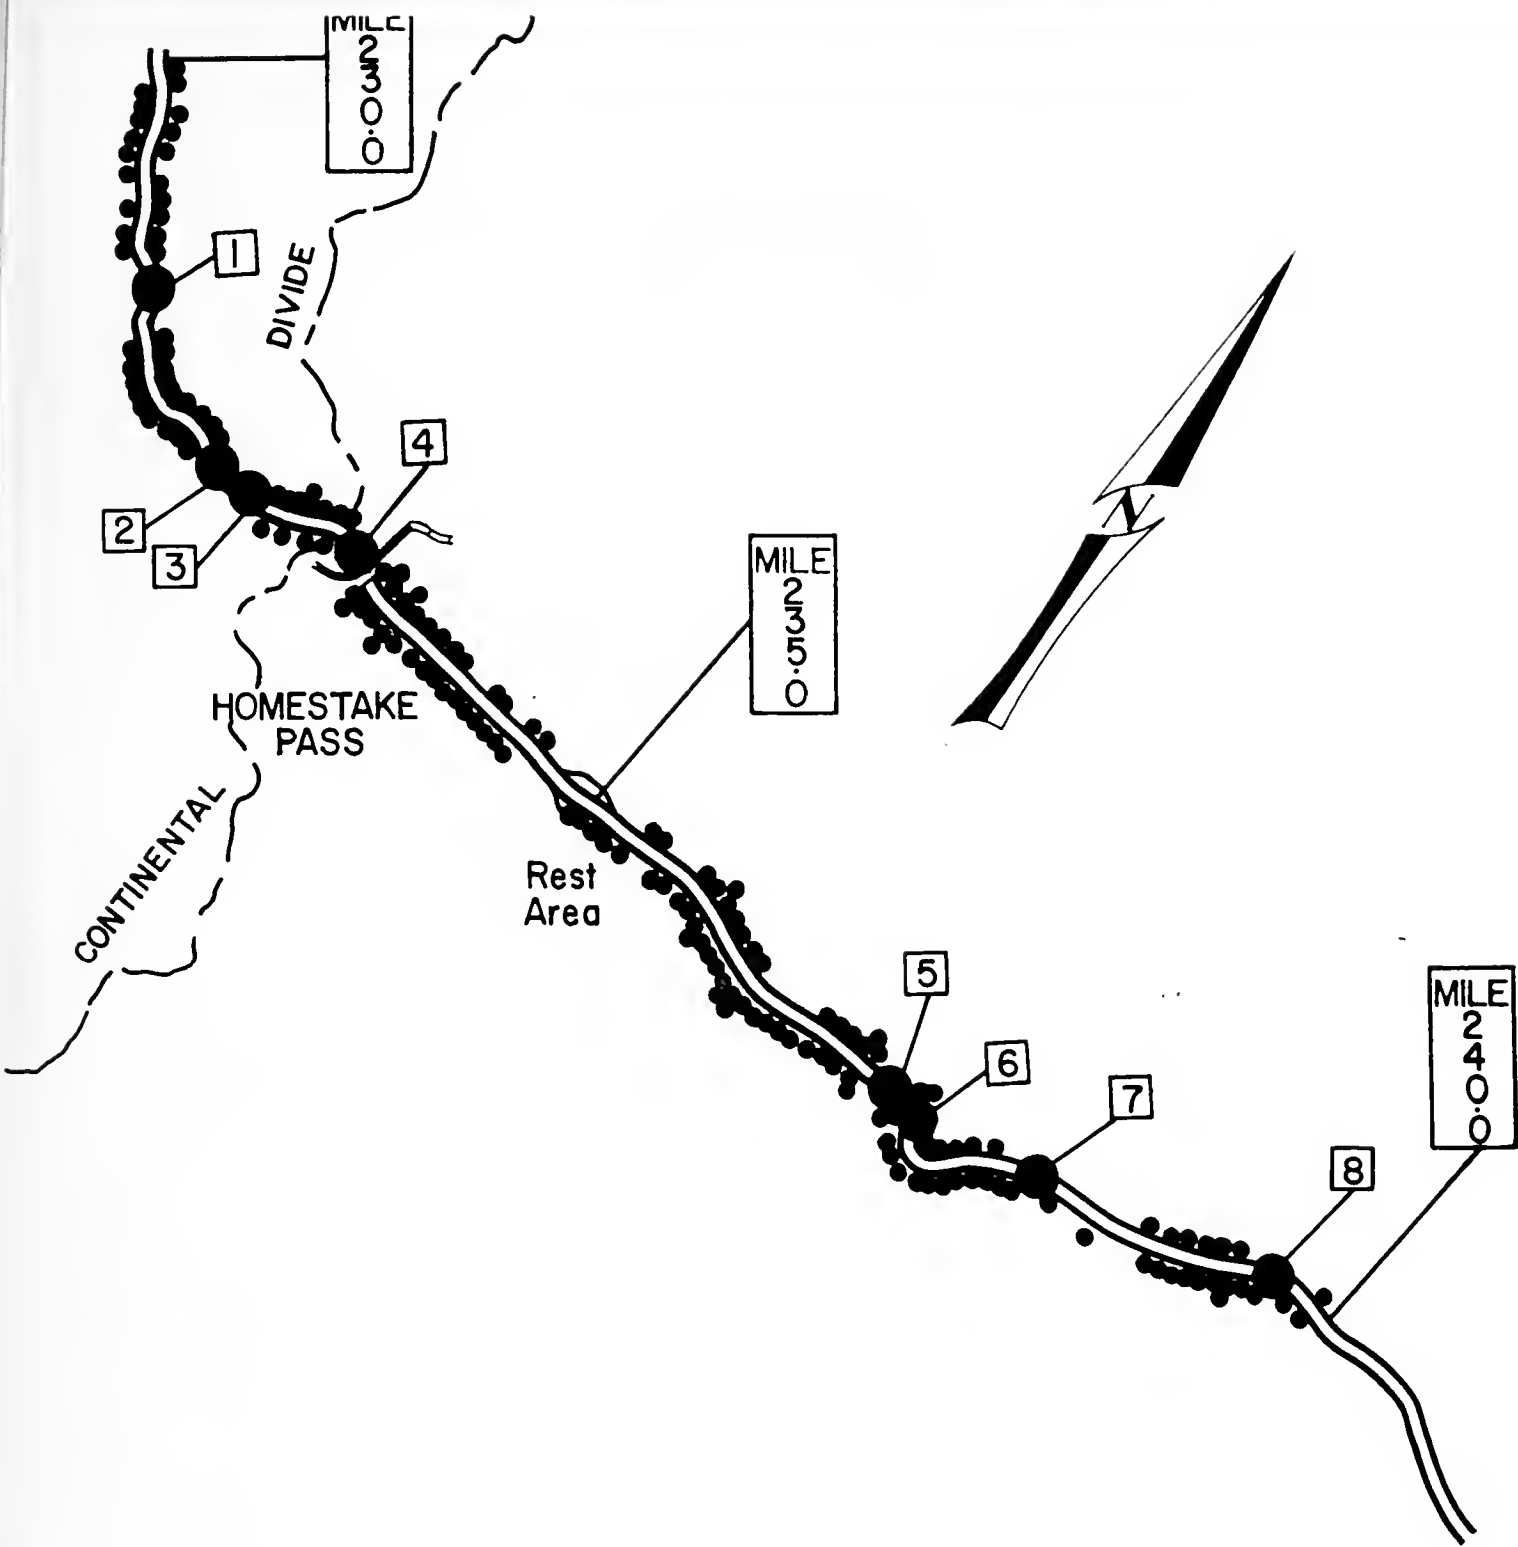
- MILEPOST 230 - MILEPOST 240
- ACCIDENT CLUSTER SITES
 - INDIVIDUAL ACCIDENTS
- Scale: 1 inch = 1 mile

General: This study section is a four-lane facility built in 1966 and has a plant mix surface treatment and crosses the Continental Divide at Homestake Pass. One interchange is affected, located on top of the pass.

Comment: Accident history is spread throughout the section. Several clusters of accidents are present particularly on horizontal curve sections and at the area of the interchange. Safety improvements, particularly directed for large trucks, has been placed on the east slope of Homestake Pass.

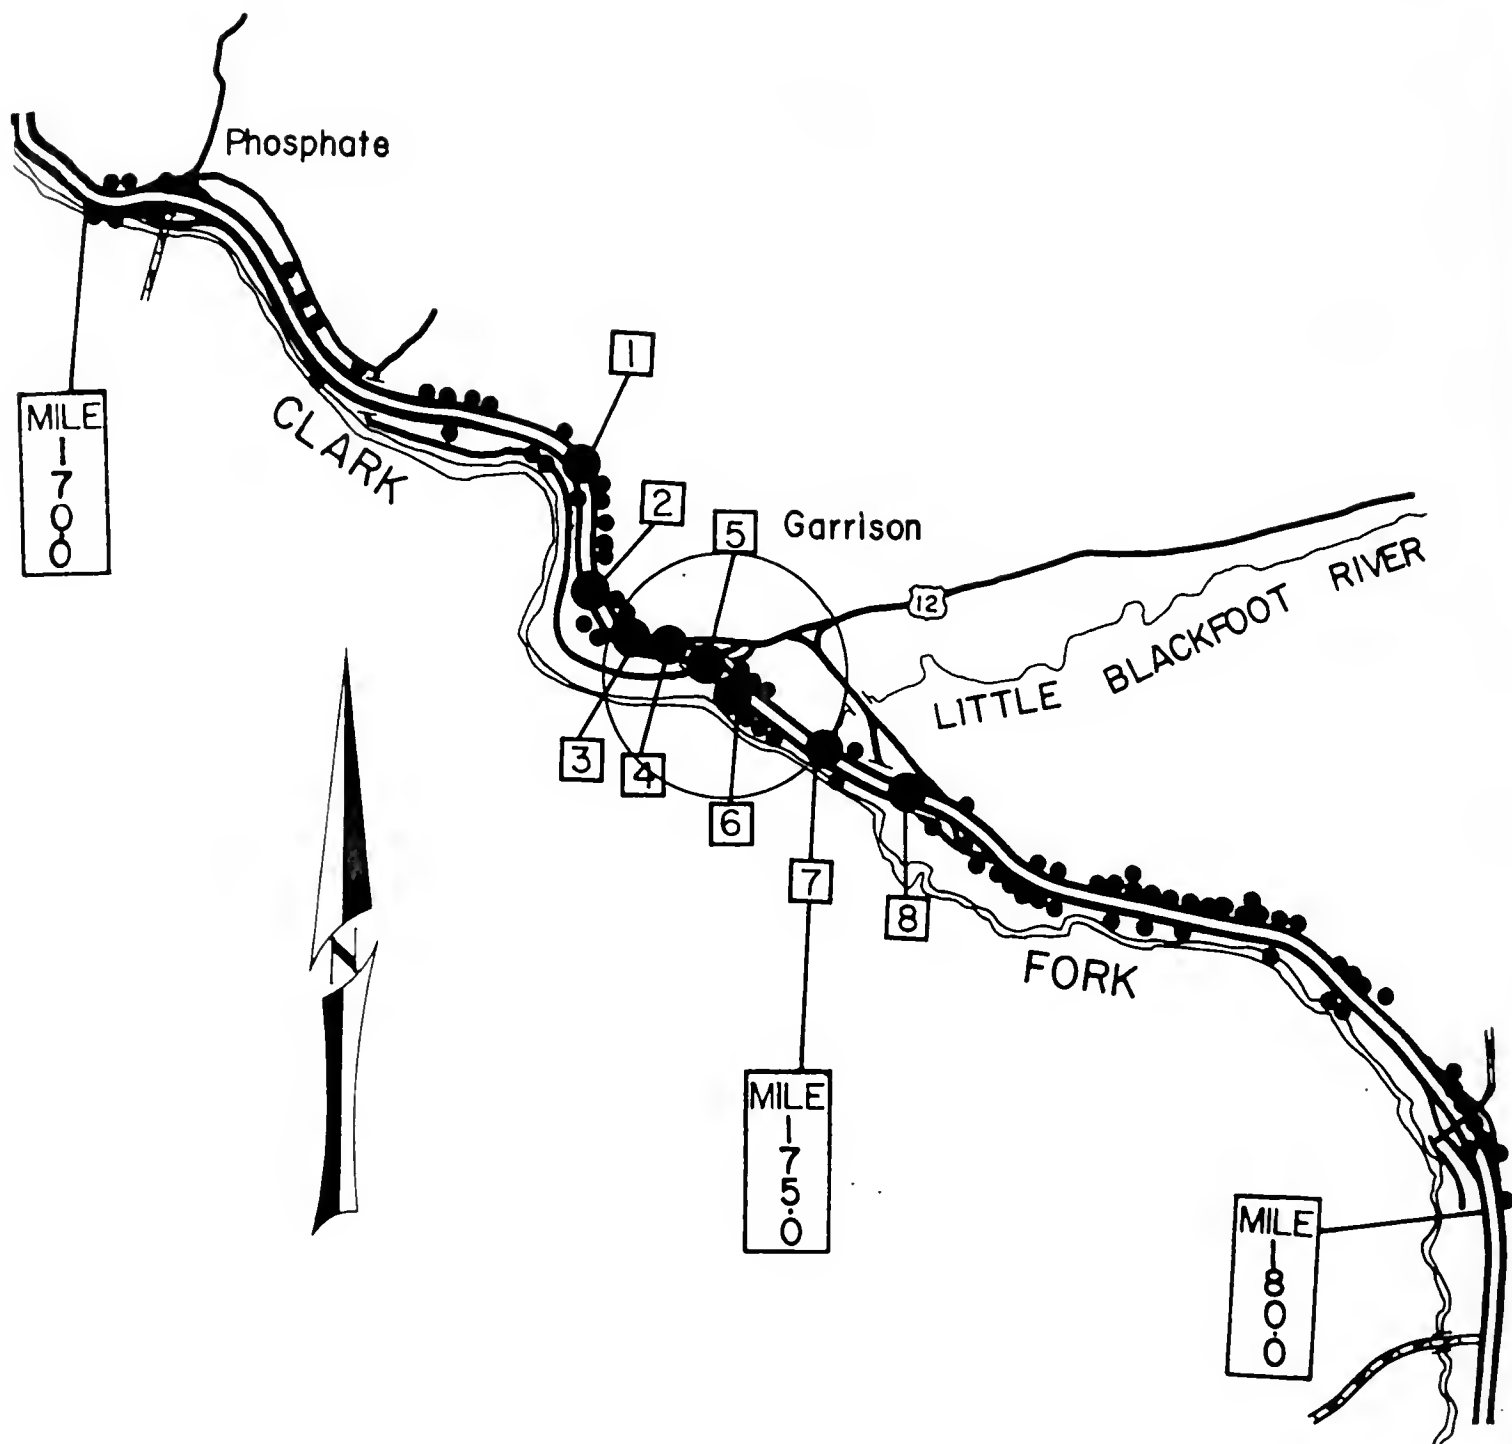
- MILEPOST 170 - MILEPOST 180
- — □ ACCIDENT CLUSTER SITES
 - INDIVIDUAL ACCIDENTS
- Scale: 1 inch = 1 mile

General: The majority of this study area was under construction at the time of the field review. The roadway section from Milepost 176+ was constructed in 1976.

Comment: Accident information shown on the accompanying map should be disregarded except for information shown from Milepost 176+ to 180. Accidents shown between 170 - 176+ reflect occurrence on the old traveled way.

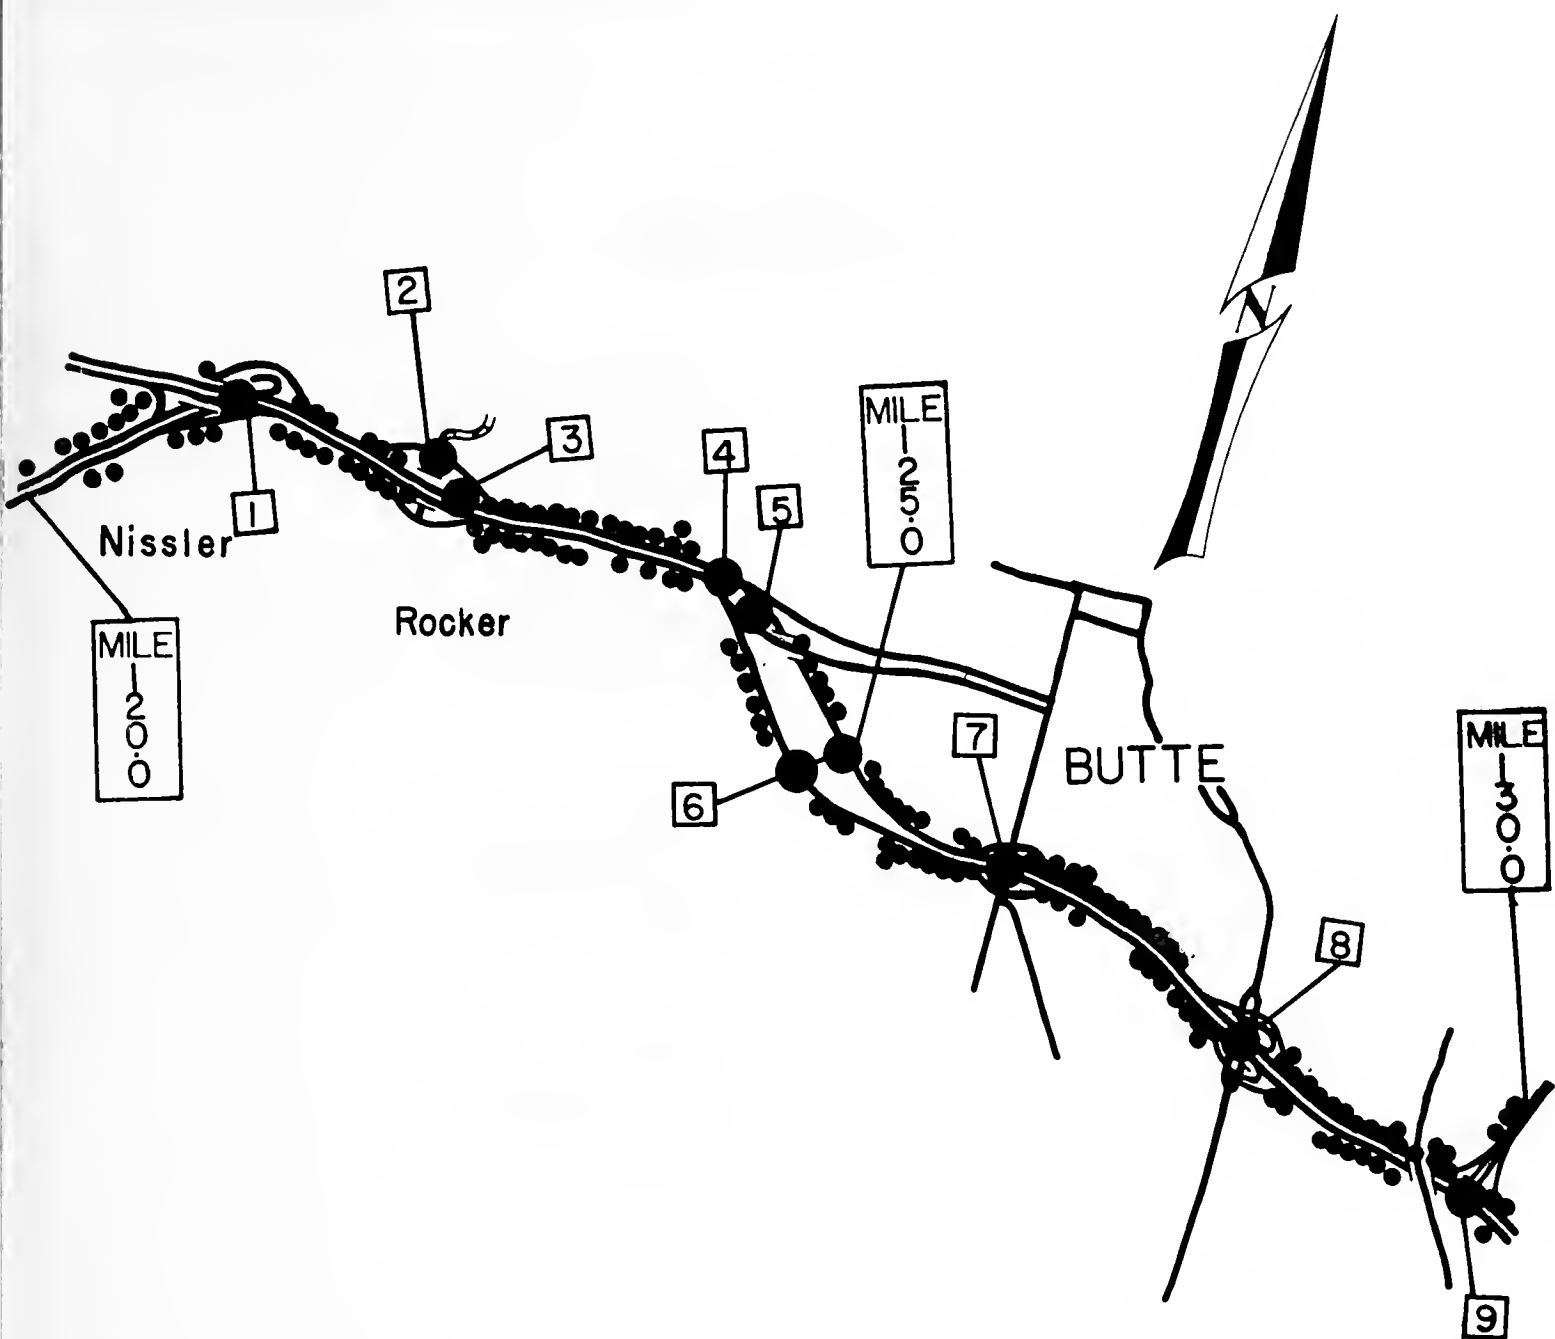
- MILEPOST 120 - MILEPOST 130
- — □ ACCIDENT CLUSTER SITES
 - INDIVIDUAL ACCIDENTS
- Scale: 1 inch = 1 mile

- General: The study section traverses the city of Butte and includes numerous interchnages. High traffic volumes and turning maneuvers attribute in part to the high incidence of accidents. The majority of the roadway in this section was constructed in the 1960's.
- Comment: Clusters of accidents have occured at all the interchange areas in this section. Cluster also occured on the west side of Butte where a left hand off ramp is present. Frequent accident occurance is spread throughout the section.

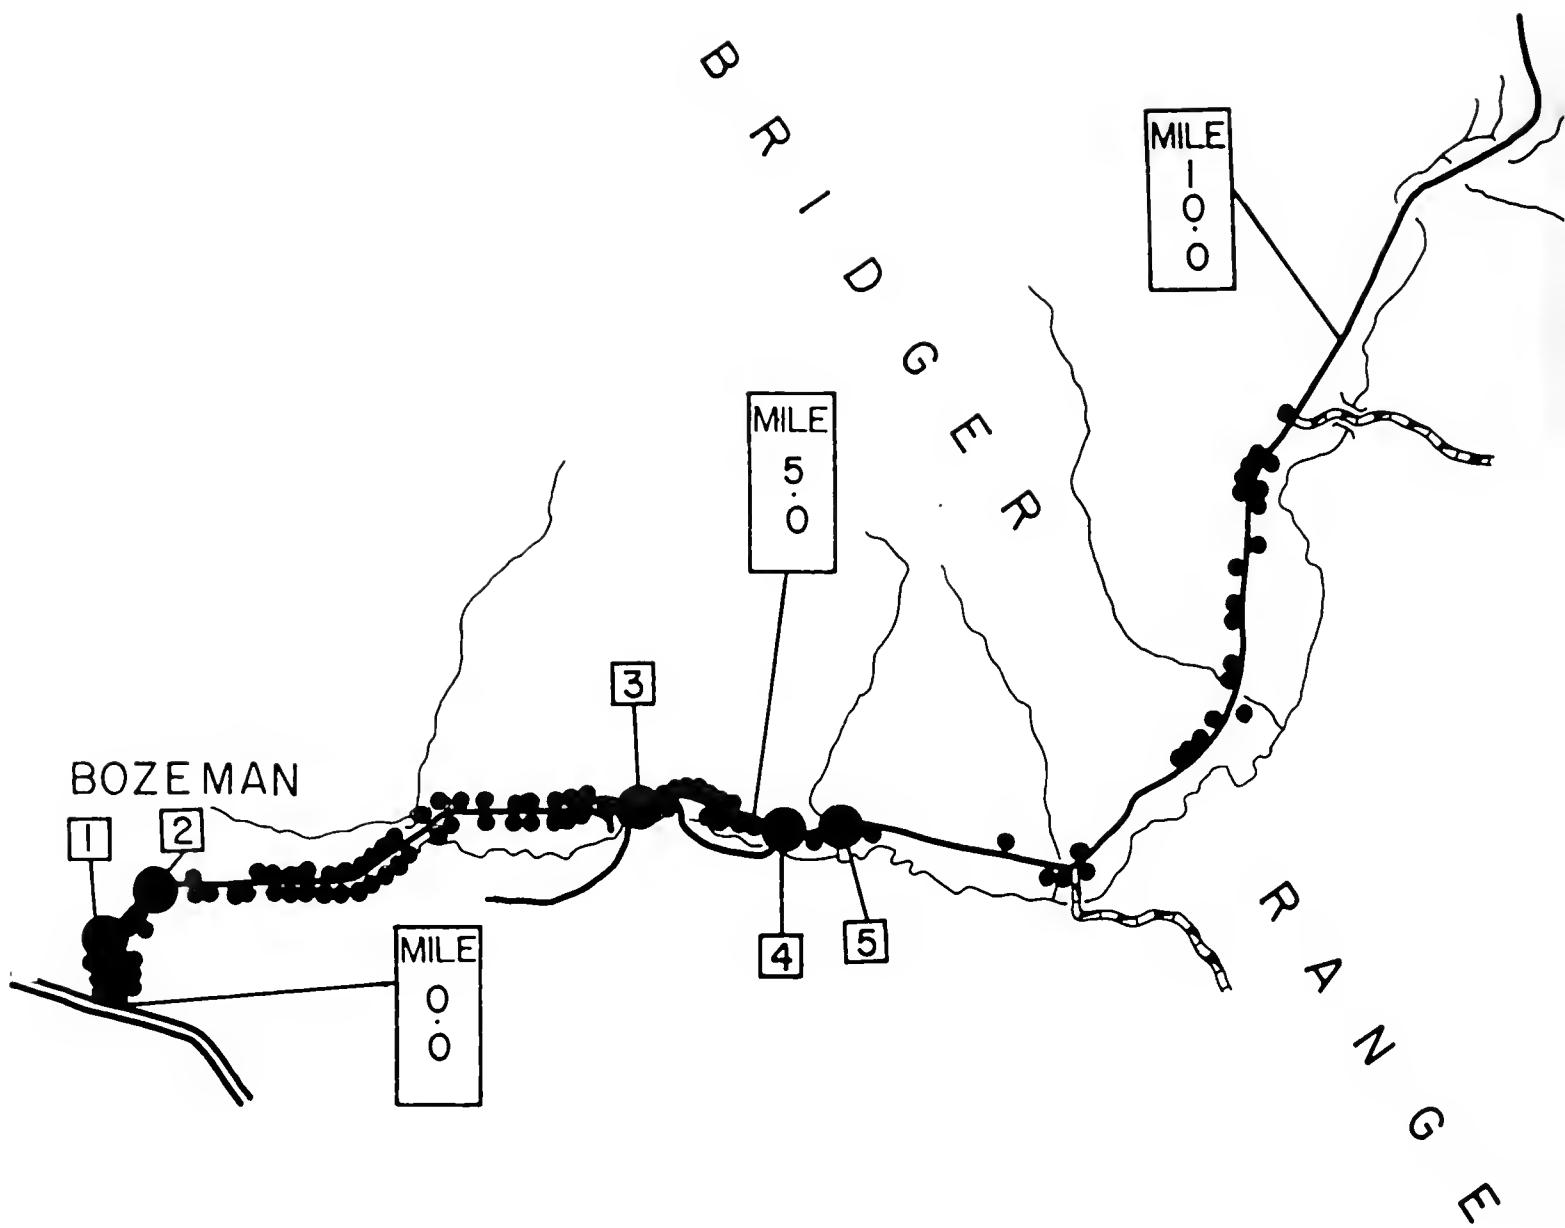
- — □ MILEPOST 0 - MILEPOST 10
- ACCIDENT CLUSTER SITES
- INDIVIDUAL ACCIDENTS

General: This study section begins in downtown Bozeman and extends northeasterly through the Bridger Canyon. This roadway is heavily used during the winter months providing access to winter sport areas. The roadway includes a detour section due to a slide condition. The roadway varies in width depending on different construct projects, however, the roadway is a two-lane plant mix surface facility.
